Pilot study to assess the potential of selected existing structures on the A30 and A38 trunk roads to provide safer crossing places for deer.

Pilot study to assess the potential of selected existing structures on the A30 and A38 trunk roads in Southwest England to provide safer crossing places for deer.

Deer Initiative Research Report 10/1
July 2010

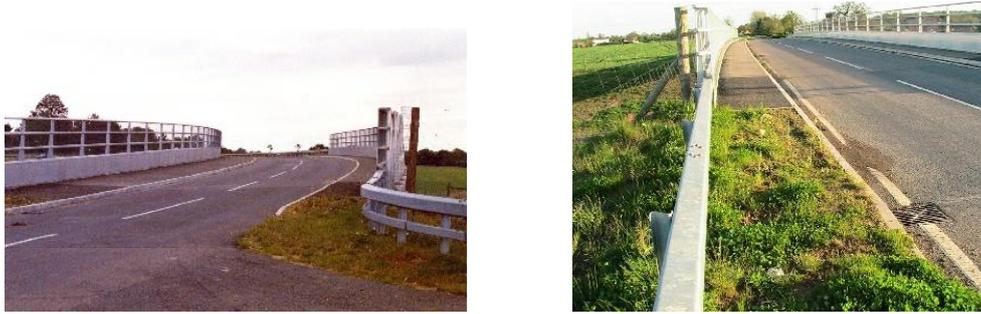
Photos 1 and 2: Examples of structures accommodating public road traffic leading over A120 Essex, known to be frequented by fallow and muntjac deer. Both structures cross over deer fenced sections of trunk road; base substrate for both is of concrete or tarmac throughout the main span. (Langbein, 2008)

2.12. It is interesting to note further that the A120 road bridges used by fallow (above) both had concrete or tarmac substrate without any strip of natural surface, although a natural substrate is widely reported as critical to achieve use by deer by many past studies. Another example of a concrete-only overpass used by fallow occurs over the M25 London orbital motorway at Copthall, Epping Forest. Fallow deer have been filmed crossing this 4 m wide and 85 m long concrete-only bridge (see Section 5: Photos 5 and 6), as well as regular deer movement across a slightly wider 7 m overpass which does have a part soil covered base (Langbein, 2007c). Further examples of joint use structures of modest size in England used by deer, include a roadbridge over the M40 near Oxford (Halcrow, 2002) which was provided with a grass and gravel verge to encourage wildlife, and use by red deer of an underpass and a narrow overbridge over the M6 Toll motorway (Cresswell pers. comm). In common with all the above examples these structures on the M40 and M6 also occur within sections of trunk roads provided with deer fencing.

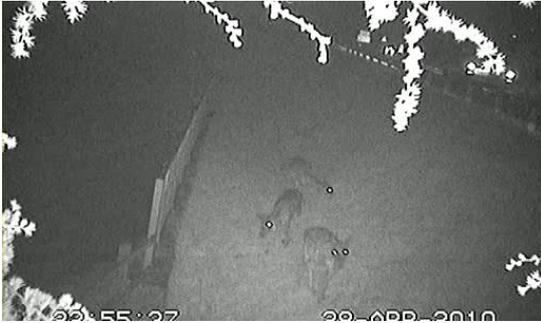
Photo 3: Freeze frame from video filming across top of Belvedere underpass with A38 trunk road on right. (for video clips see Appendix IV)

4.34 Good footage of deer (readily recognisable as such) was obtained at one of the structures (Belvedere Cross). Here no fewer than at least seven different fallow deer were filmed, not seen moving through the structure itself, but recorded walking across the top of the underpass along the verge of the A38 trunk road. Several sequences filmed here show deer feeding calmly within just 2m to 6m of the main (eastbound) carriageway. Despite the close proximity of busy trunk road traffic, which on video footage can be seen passing in the background, groups of fallow deer filmed at night appeared to take little notice of the nearby traffic (see Video clip 1 – Appendix IV), and freeze frame Photo 3 below). Several further fallow deer were recorded above the same underpass during daylight soon after dawn. Video Clip 1 shows deer grazing or slowly walking along the trunk road verge above the underpass for nearly 15 minutes, with heavy traffic passing alongside; Clip 2

shows deer walking up the embankment in daylight, within just one metre of the edge of the structure and the road below. The video recordings and presence of very extensive deer slots and dung found along the verges (Photos 4148 - 4151) indicate that fallow use these areas very commonly as a normal part of their home range. That is, approaches by the deer onto the trunk road verges at this location appear to occur mostly not with intention to actually cross the main road, but to feed on the verge or move across the side road. The regular exposure to the flow of road traffic closeby is likely to lead the local deer to become increasingly habituated to the noise of approaching vehicles, and possibly less cautious of crossing into the traffic at other times.

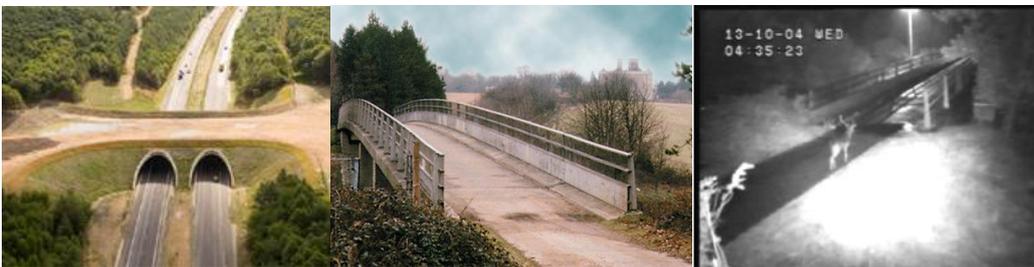
Photos 4, 5 and 6: A large green habitat bridge in Switzerland (left) and a narrow joint use bridge with concrete substrate across M25 nr London (centre & right): each structure was designed for a quite different set of aims but both are regularly used by deer.

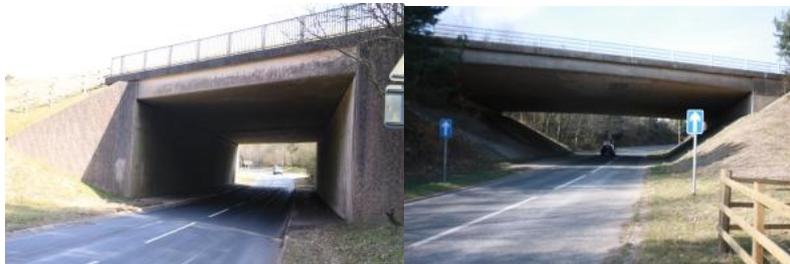
5.21 The A38 across Haldon Hill between Kennford and Harcombe has been a deer collision accident hot spot for many years. Haldon Forest holds a fallow deer population well in excess of 500 head, as well as large numbers of roe deer and occasionally some red deer. Between 10 to 20 deer casualties are recorded by the managing agents each year within a distance of around 5 km, while many others are likely to go unreported. Two road underpasses beneath the A38 included in the present study occur within the Forest at Belvedere Cross (Photo 3452) in the northern part of the forest, and another at Harcombe Cross [Photo 3465] south of the Forest. Signs of deer were found within less than 10 to 50 m of entrance to both underpasses, but not clear evidence of current crossing through these structures. However, extensive frequent fallow deer activity (as shown by video recordings made – see Video Clips 1 – 3, Appendix IV) was noted directly on top of the overpass within 2 m of the main trunk carriageways. Deer activity was also noted within woodland adjacent to Harcombe Cross underpass.

Photos 3452 and 3465 – Underpasses beneath A38 at Belvedere Cross (left) and Harcombe Cross (right)

5.22 In case of Belvedere Cross underpass it seems very likely that movements of fallow deer through this underpass could be attained (or increased if already occurring to a limited extent) through installation of a number of short length of fencing. The latter would require careful design lay-out to ensure minimal risk of deer entering the inside of the fenced section through end-runs and maximise its use to deter deer from crossing the trunk road. The opportunity may also exist in this area for possible use of less than full-height deer fencing or fencing erected on the slope of existing embankments that would enable deer to cross in one direction but not another. If such adaptation is found practical after closer investigation and resources are available, some systematic pre and after monitoring of deer use and behaviour around the underpass should be included as part of the scheme, ideally using CCTV equipment or else alternative methods alongside continued monitoring also of deer collisions, in order to assess the actual effectiveness and cost effectiveness of adaptations undertaken.

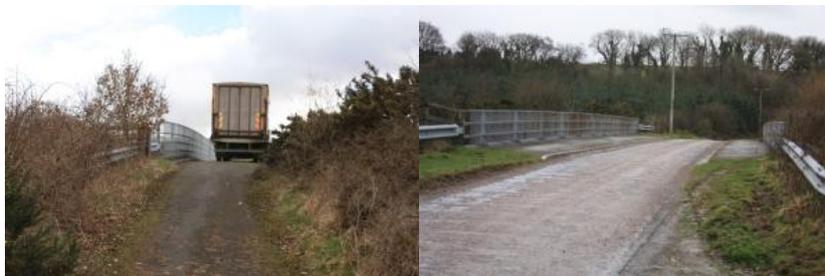
5.25 Ellacott farm overpass (Photos 4111; 4119) is a narrow farm accommodation bridge free of any road traffic and only occasional farm vehicle access. At the time of survey a lorry had been parked continuously on the structure for several months, blocking much of the path (Photo 4111) , whilst a metal gate and piles of silage bales block much entrance onto the structure from the south. Signs of deer were found within less than 50 m on the northern side, though no signs noted directly on the (hard substrate) bridge itself. Although this overpass is only 4m wide, it is very favourably located to serve as a deer crossing in a very quiet area where Ebsworthy wood and a new tree plantation abut closely to its northern side and pasture fields to the south. The main adaptation suggested in this instance would centre around removal of current obstacles to deer use of the structure; i.e. by ensuring no farm vehicles or other machinery are parked long-term on the structure in future, and other obstacles such as silage bales and gates are removed to enable freer passage for deer and other wildlife. Stock fencing adjoining the structure especially on the southern side should also be adapted in a way that enables ready access by deer. In addition, consideration should be given to improvement of the woodland / trunk road boundary fencing for the c. 2 km section located between the two overpasses, to help channel deer to the safer crossing places and prevent them crossing over the trunk carriageways in this area.

Photos 4110 and 4096 – Overpasses over A30 at Ellacott Farm (left) and Ebsworthy Farm (right)

5.26 Ebsworthy Farm overbridge is a somewhat wider (7 m) overpass carrying a minor road / lane (e.g. Photo 4096, 4102) with very light local traffic flow. Woodland abuts within 75m on the southern side, with pasture and moorland to the north. Signs of red deer activity were found within 75m of the entrances, and although no direct evidence of deer crossing activity was noted during the short pilot survey, it seems likely that deer may already use the bridge to some extent. The
